Manhole Inspection Summary

Manhole # S31GG_041MH

Insp Date: 1/19/07 9:11 AM

Location Address: **149 BREVARD ST**

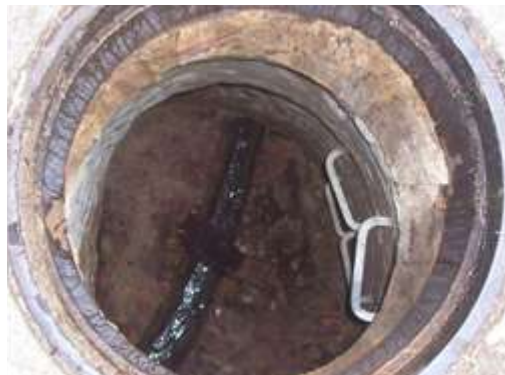
Top View

Bench debris.

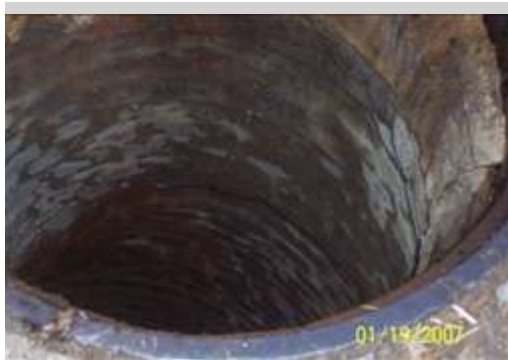
Defect

Adjustment, Corbel and Barrel infiltration - other side.

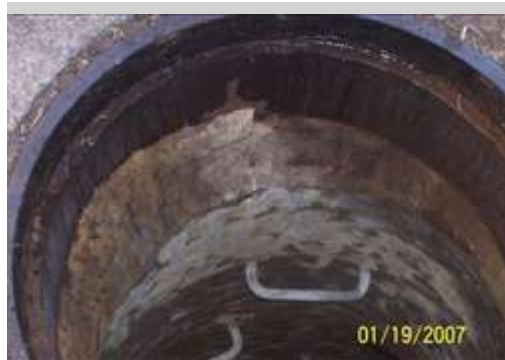
Defect

Adjustment, Corbel and Barrel infiltration.

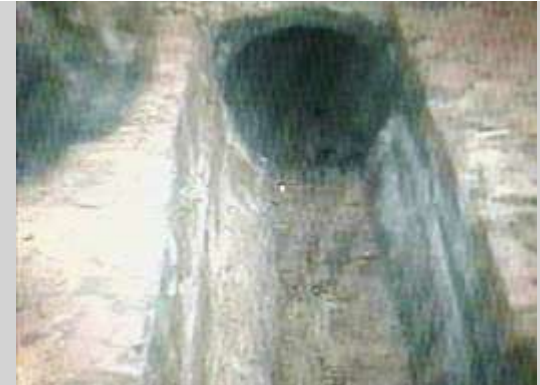
8 in. Circular Gravity Sewer Pipe Out @ 12 O'Clock

Infiltration: **Evidence** Pipe Seal Cond: **Unknown**

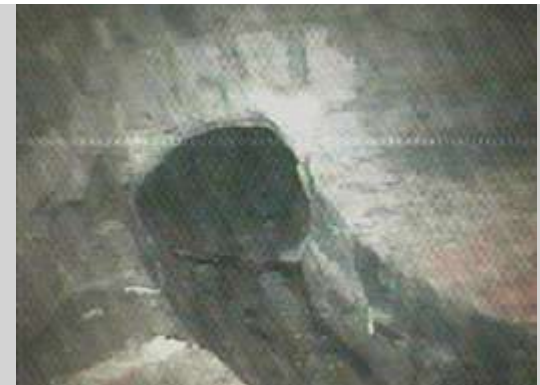
8 in. Circular Gravity Sewer Pipe In @ 7 O'Clock

Infiltration: **Evidence** Pipe Seal Cond: **Broken**
